SAFETY CONCERNS WITH HEAVY VEHICLE ACCIDENT REPAIRS

Heavy Vehicles on our Roads

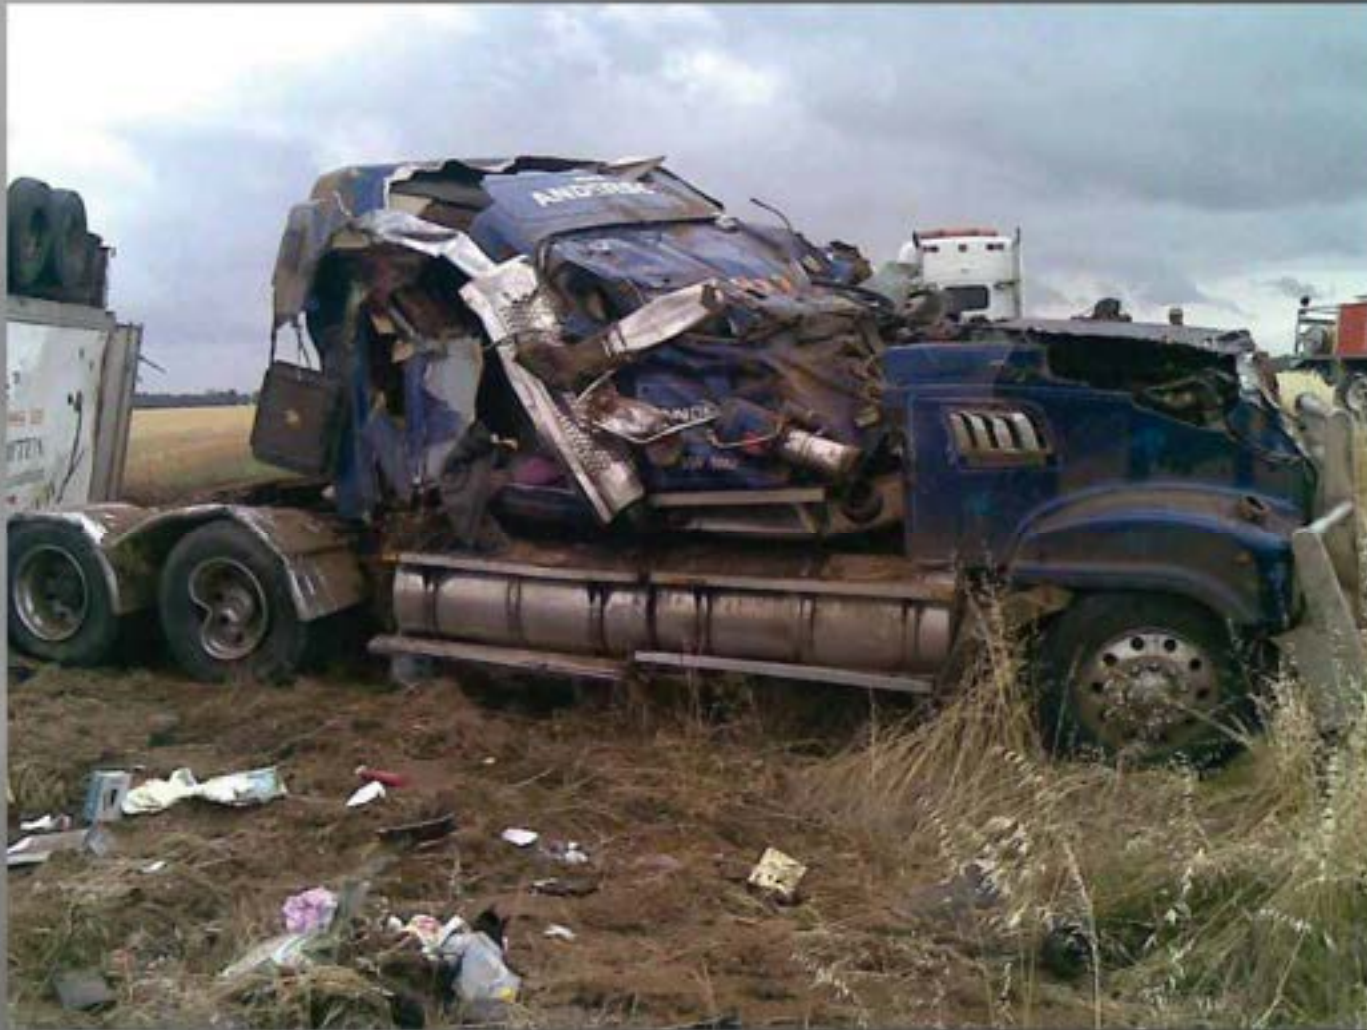
VEHICLE WAS DEEMED A TOTAL
LOSS BY INSURANCE COMPANY

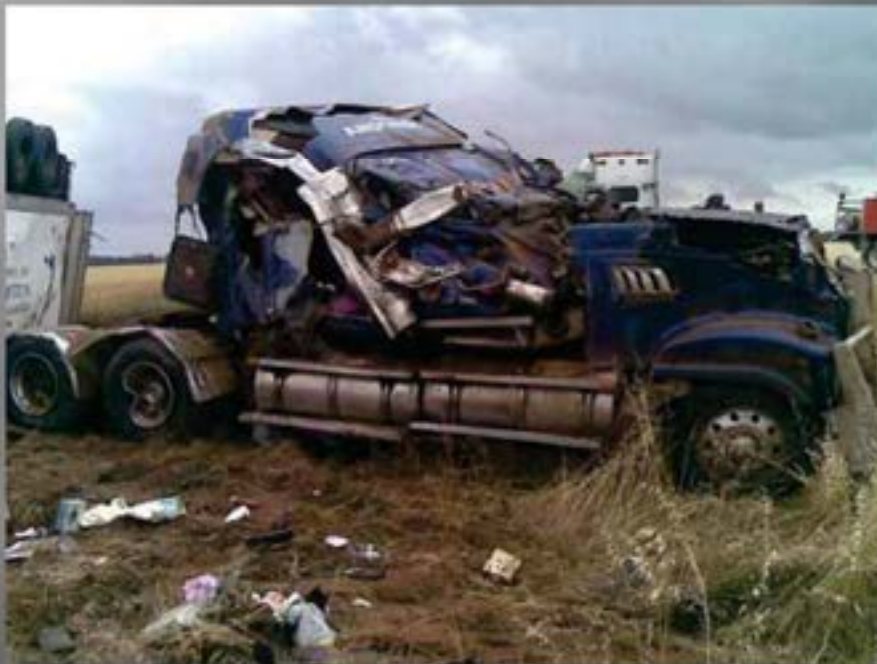
VEHICLE WAS SOLD AT AUCTION TO AN
UNLICENSED, INEXPERIENCED "BACK
YARD" REPAIRER

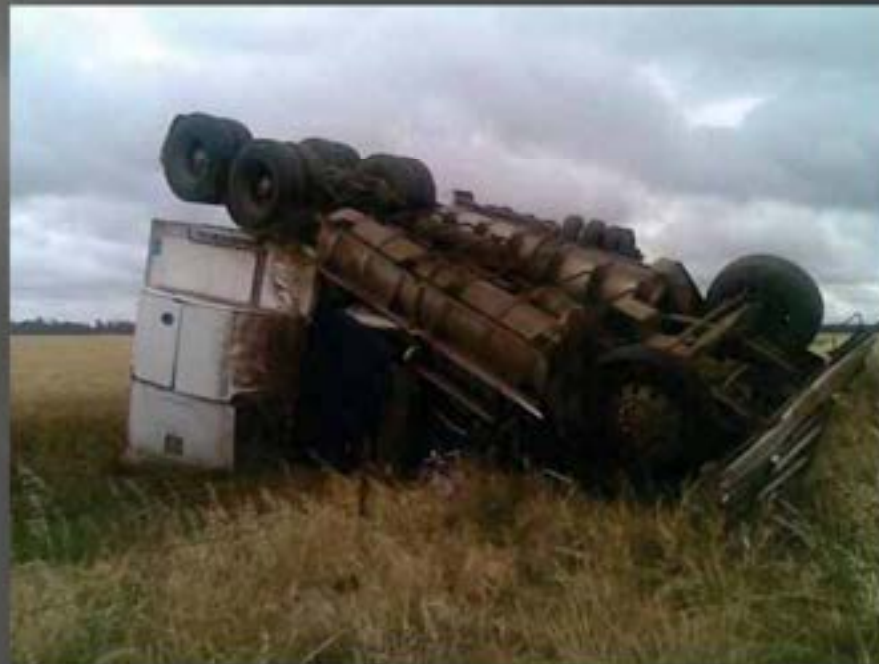
This vehicle is now back driving on our roads after a “backyard” repair!

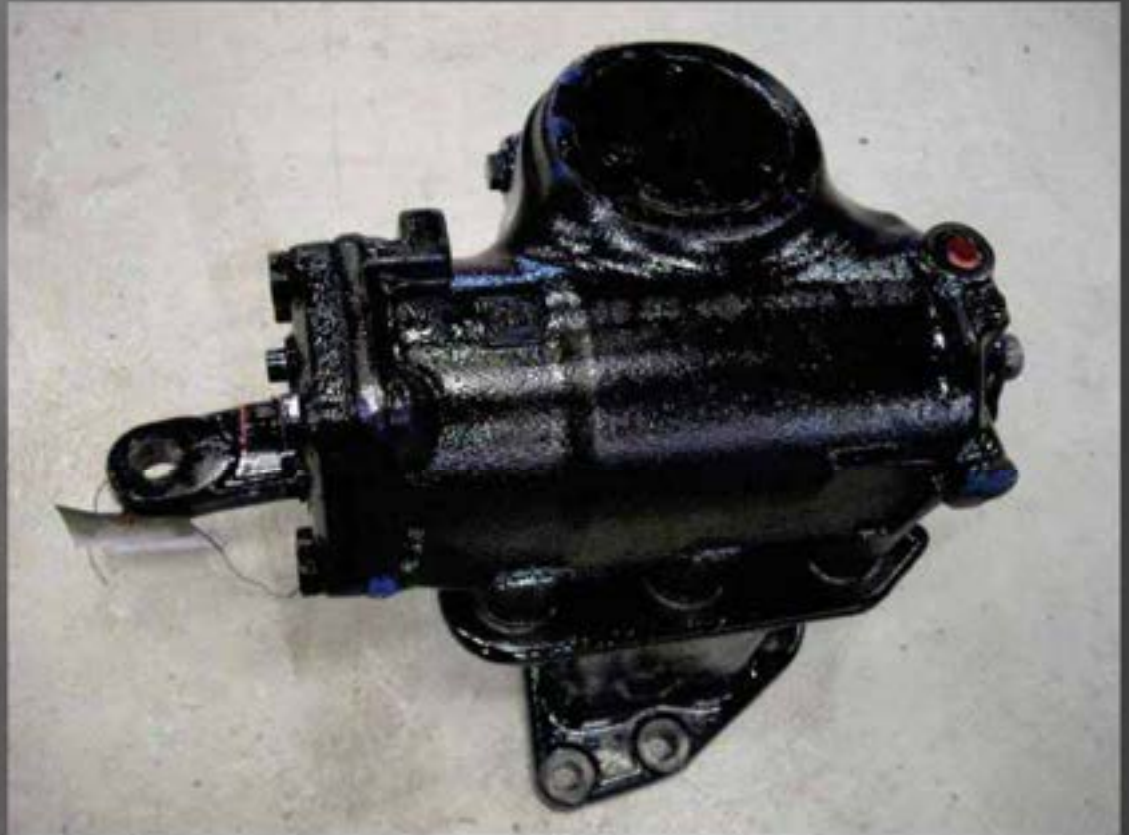
- Volvo prime mover involved in minor accident. There was no impact or visible damage to steering box.
- The impact point on this vehicle was the right hand wheel.
- Due to inertia forces, the impact travels from the wheel to the drag link assembly.

Removal of steering box shows no sign of damage.

- Even when the steering box was removed, no visible damage was evident

- As these steering and suspension components are sealed, it is impossible to check if they are in a serviceable condition unless a full strip down occurs.

- Inertia forces then travel from the drag link into the steering box.

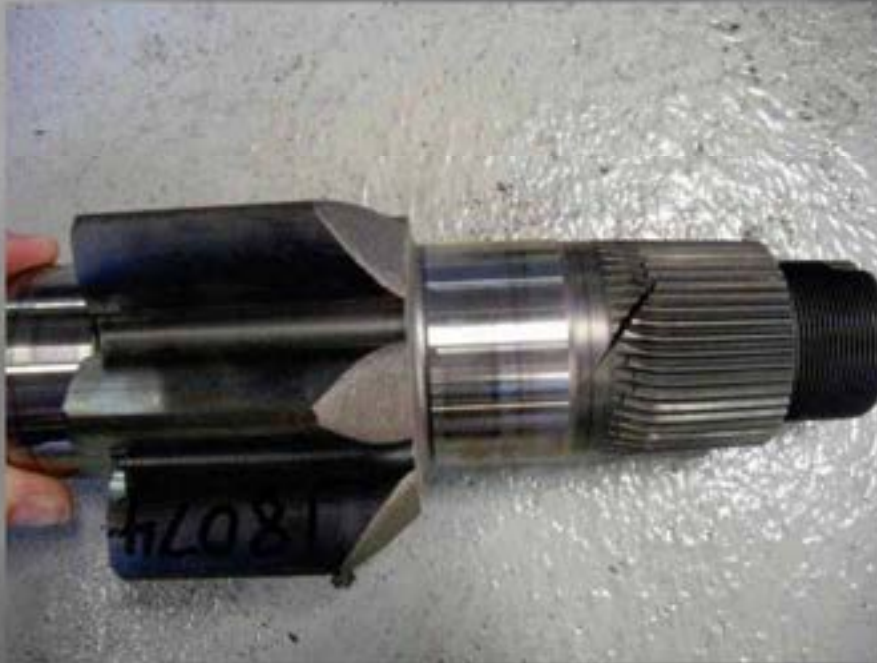
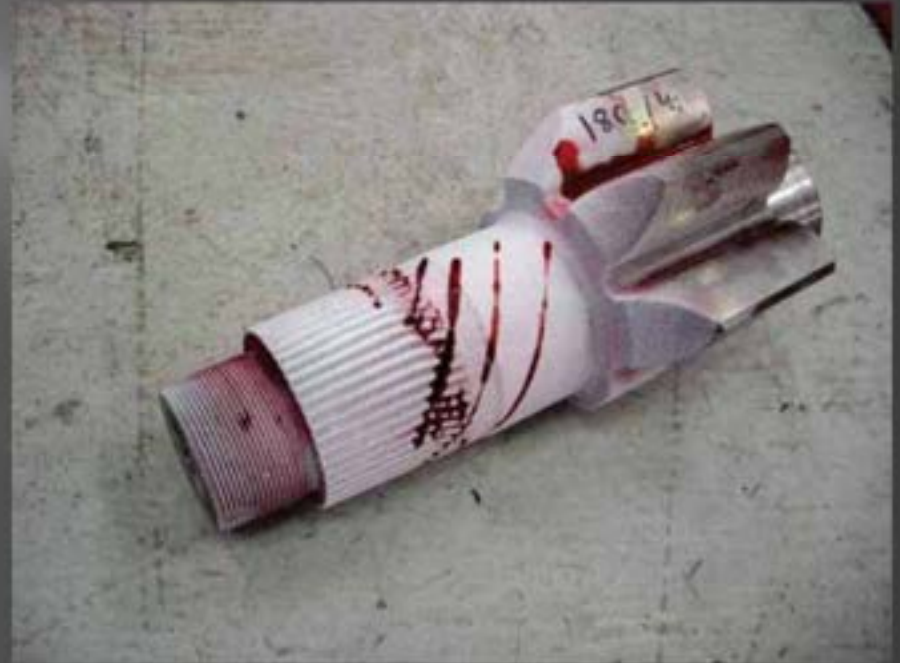
Steering box shaft found to be cracked and unserviceable!

•NOTE MAJOR CRACKS IN STEERING SECTOR SHAFT

•EVEN CRACK TESTING PICKS UP CRACKS THAT ARE NOT EVIDENT PREVIOUSLY

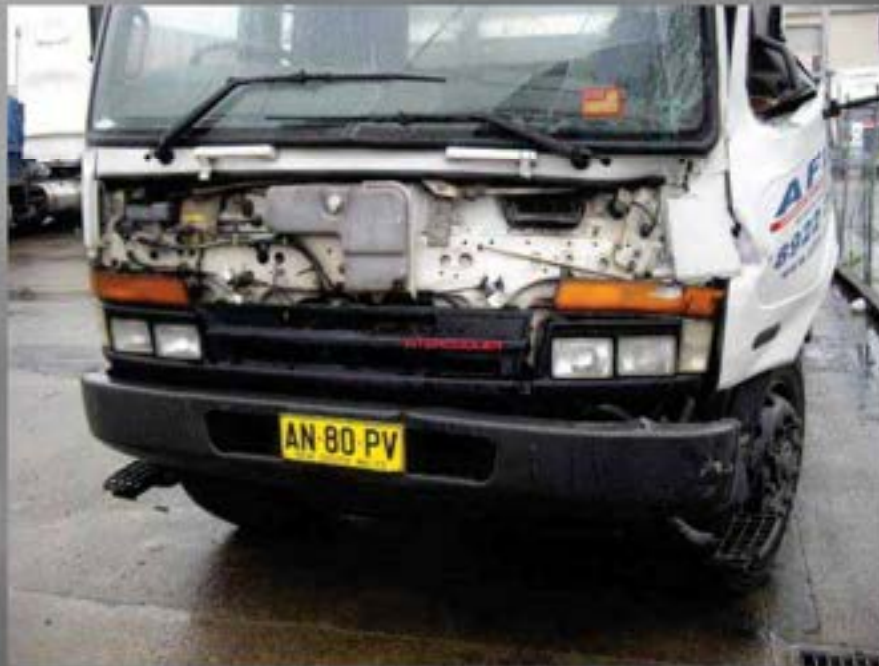
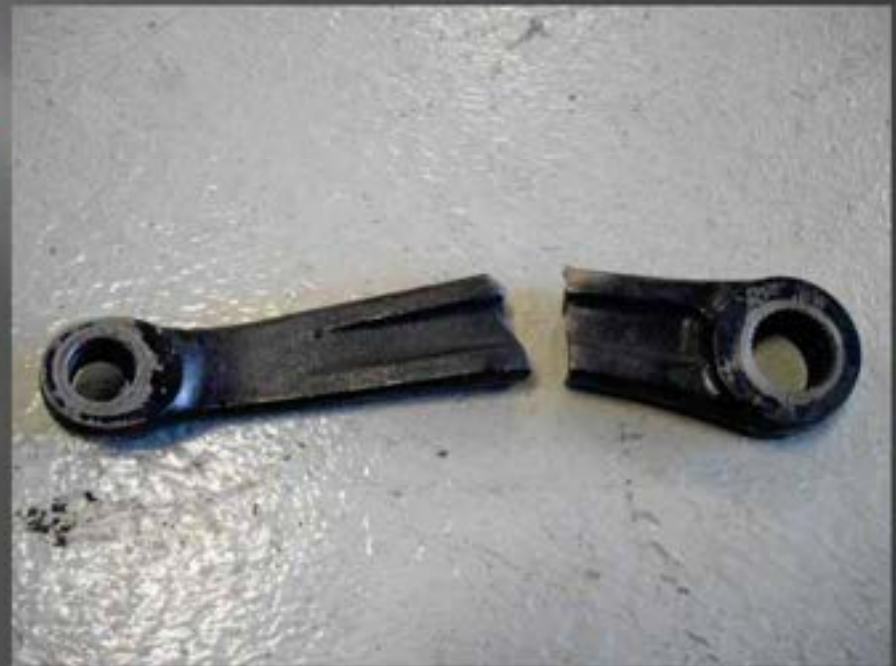
Steering Pitman Arm cracked in half!

•IMPACT DAMAGE IS ON THE
LEFT HAND SIDE OF THE CABIN

•STEERING BOX AND PITMAN ARM
IS LOCATED ON THE RIGHT HAND!

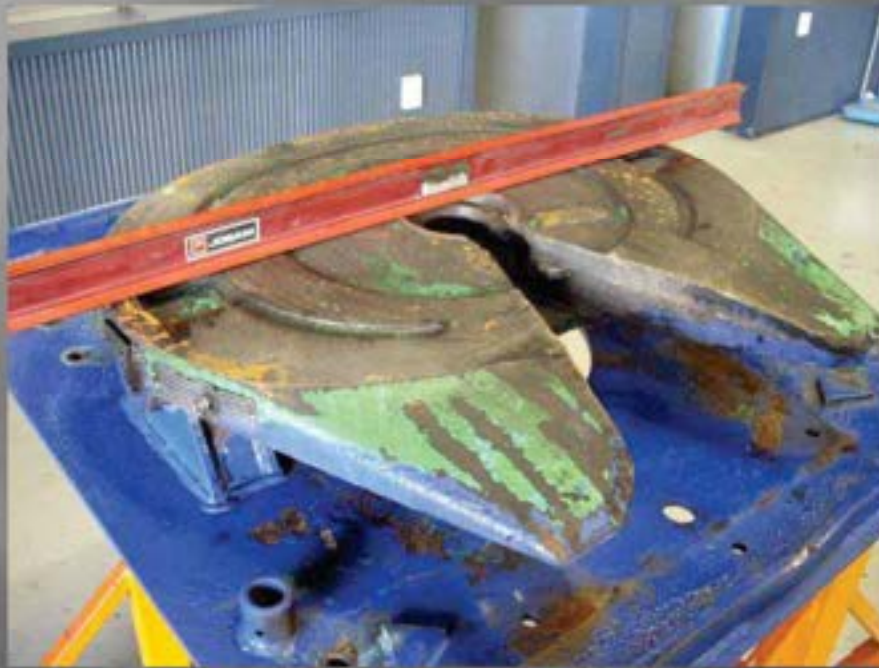
Turntable base plate bent and jaw kit cracked!

•TOP DECK OF THE TURNTABLE
PULLED UP BY TRAILER

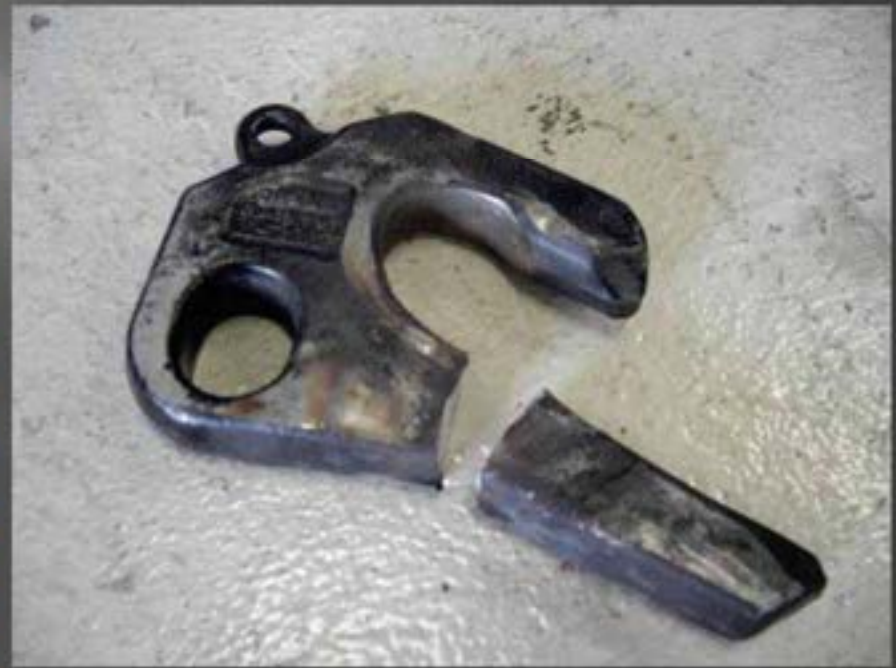
•JAW LOCK PIN HOLDING TRAILER
TO TRUCK CRACKED IN HALF!

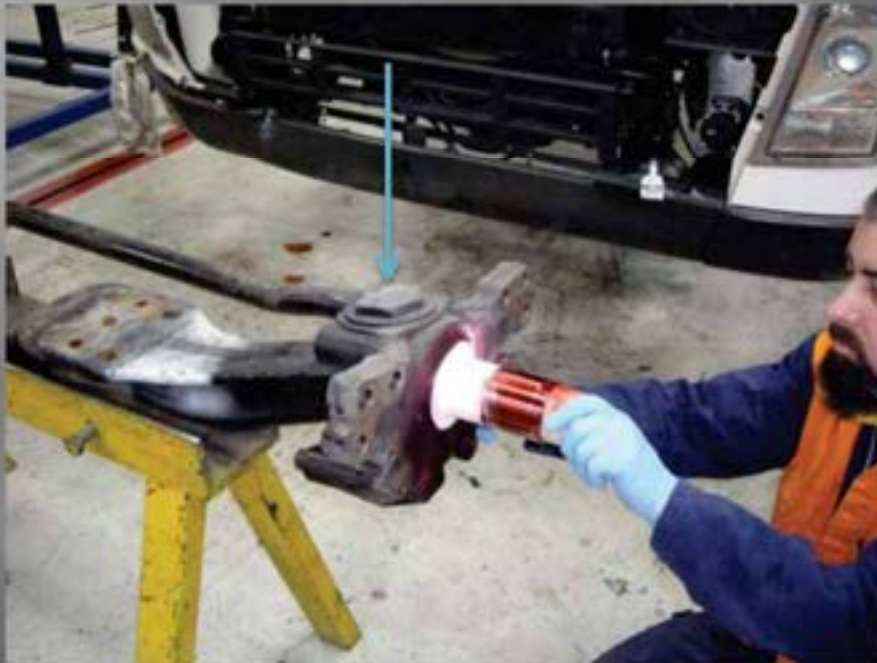
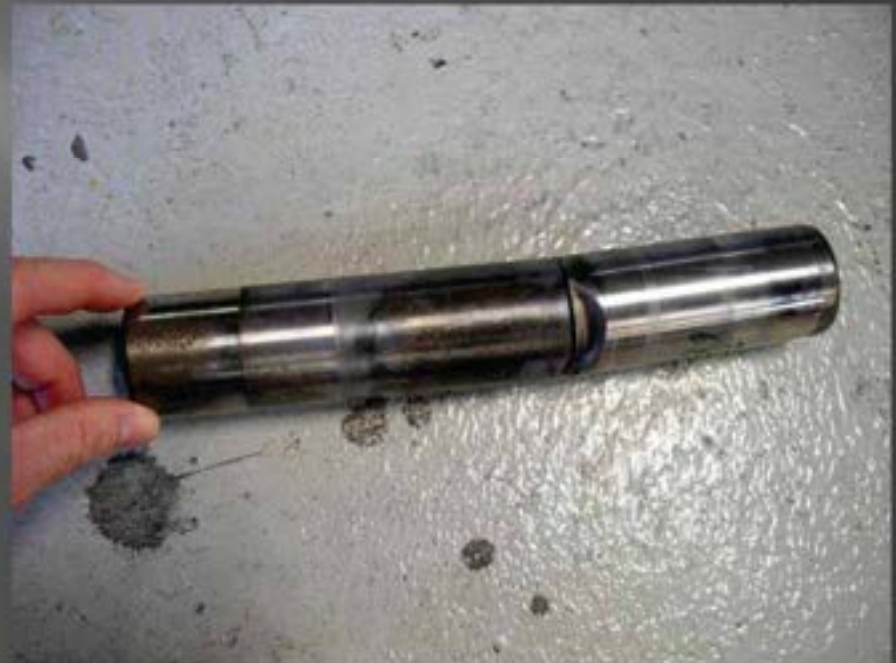
- CRACK TESTING OF KING PINS
- X-RAY OF AXLE
- LATHE TESTING

- TECHNICIANS ARE TRAINED IN ALL ASPECTS OF HEAVY VEHICLE SAFETY.
- NO EXTERNAL DAMAGES EVIDENT BUT KING PIN WAS FOUND TO BE CRACKED!

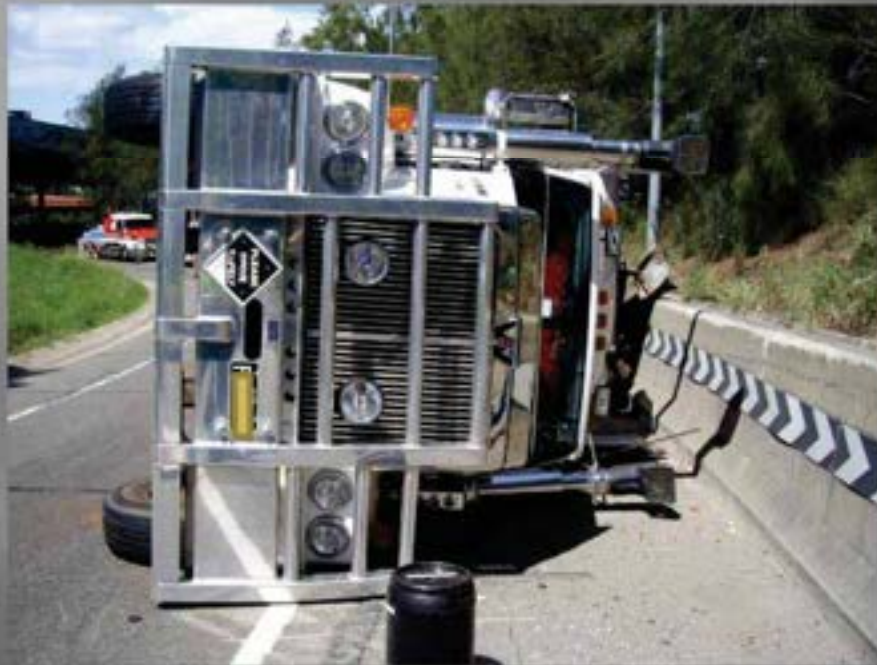
Damage is not always evident.

·SOMETIMES, EVEN IN SEVERE ROLLOVER CASES, THERE DOESN'T APPEAR TO BE MUCH DAMAGE.

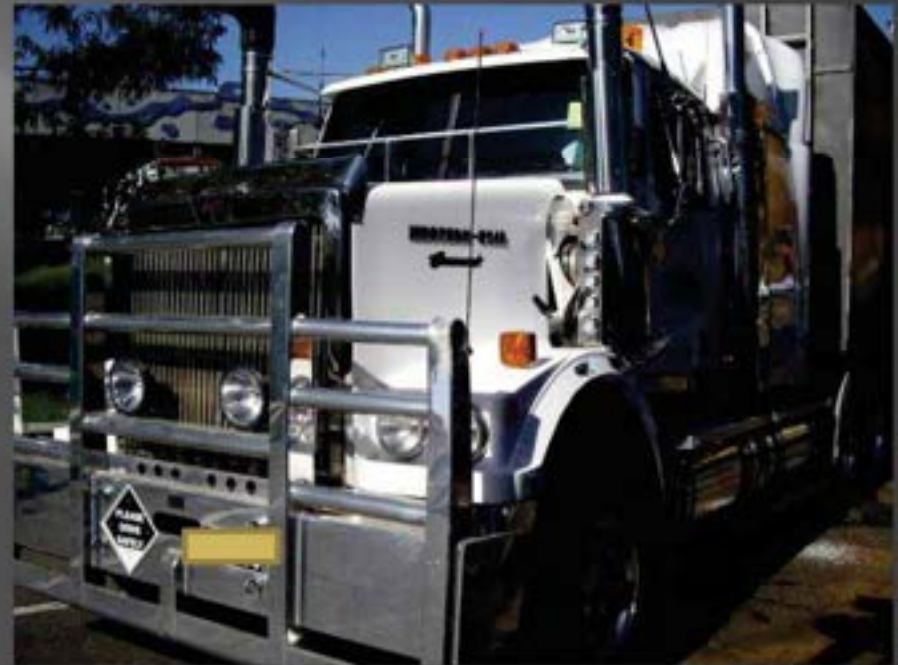
·THIS VEHICLE WAS WRITTEN OFF FROM THE INSURANCE COMPANY AND SOLD BACK TO THE AUCTION YARD.

- This vehicle was then purchased back from the auction yard and repaired by an unknown, unlicensed repairer!
- Does the “back yard” repairer know what to look for?
